Minerals Inspection Report

Mine Name: North Tailings Impoundment	Permit Number: M/035/0015	Mine Status: Active
Operator Name: Rio Tinto - Kennecott Utah Copper	Inspection Date: August 21, 2013	Permit Fees: Paid
Inspector(s): L Heppler, A Abate, T Nicolaysen	Inspection Time: 2:00 PM	Bond Amount: \$22,166,333
Attendee(s): T Lindsay, T Heaton	Weather: Sunny, Dry	Bond Escalation: 12/20/2016
Inspection Purpose: Routine annual inspection		Prior Inspection: May 10, 2012

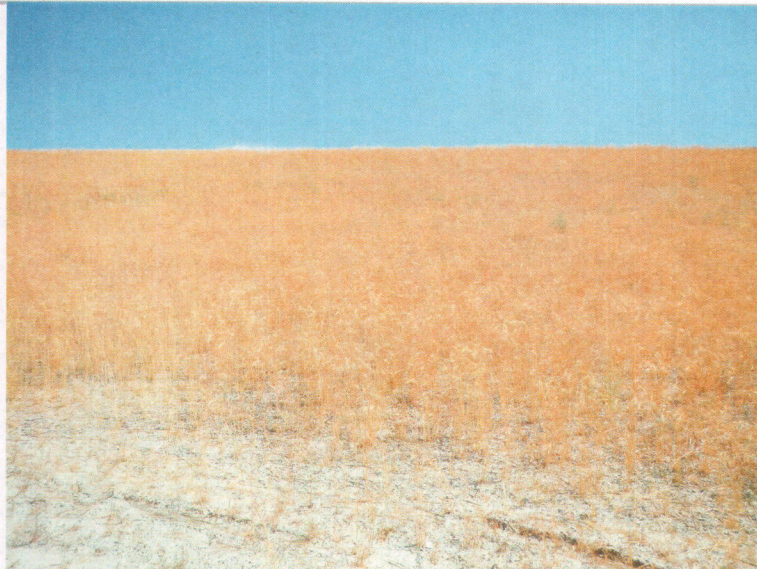
8. <i>Soils</i> No soil stockpiles are noted at the time of inspection, but the north facing slope of the tailings impoundment has been top soiled with imported borrow. There was no topsoil available at this site to be borrowed.	<input checked="" type="checkbox"/>	<input type="checkbox"/>

North slope of tailings impoundment -Topsoiled and seeded - mono-culture

OGM recommends continuing with biodiversity of vegetation. OGM to continue annual inspections and monitor the site when in the area. Permit M/035/0014 covers the tailings impoundment expansion adjacent to and north of the original Kennecott tailings impoundment (permit M/035/0002). Both permit areas were inspected on August 21, 2013.

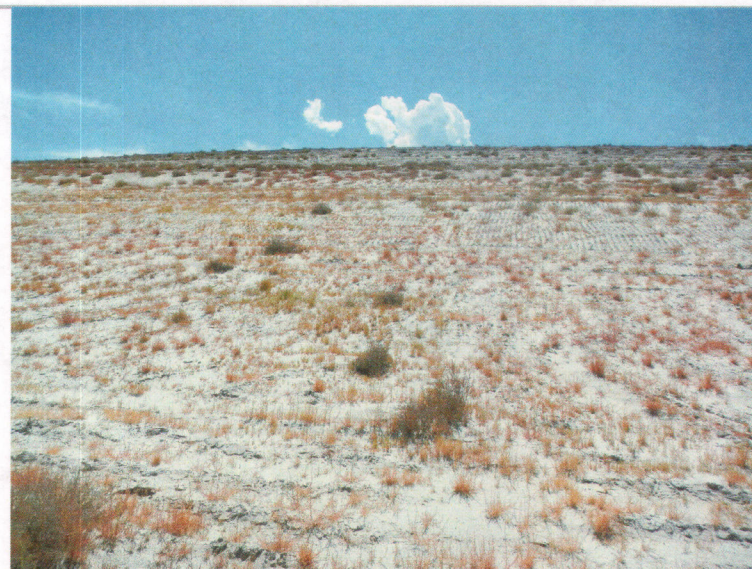
East facing slope of tailings impoundment- dominantly weeds

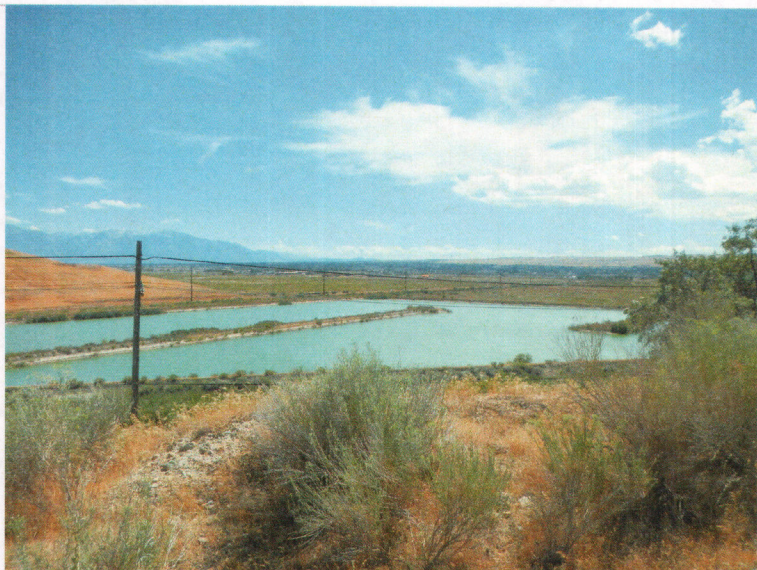
Clarification canal - east side of tailings

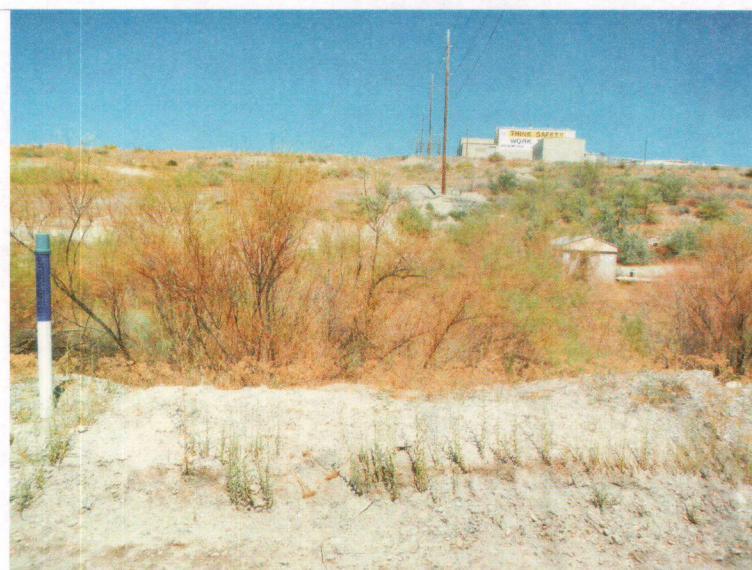
Salt Cedar - (Tamaricks) - need to be treated
